Albany Grain Silo Repairs

PROJECT DETAILS

Centrals have been contracted to perform extensive concrete repairs to the 10,000T grain storage silos located at CBH's Albany Port Facility.

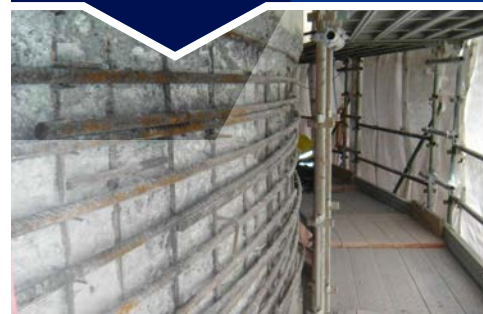
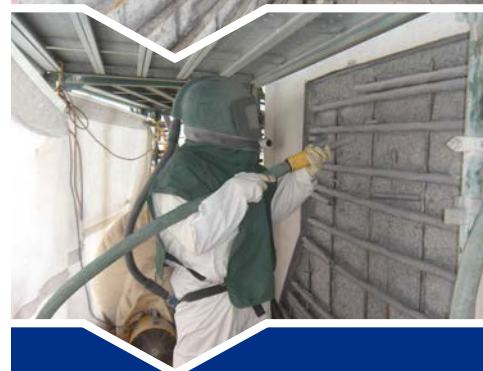
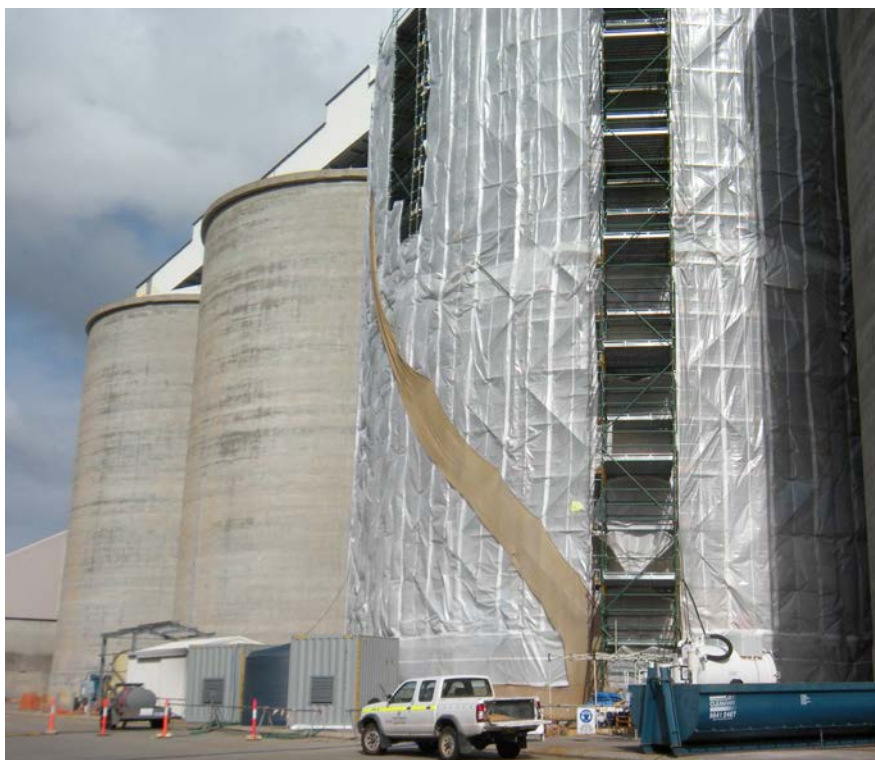
The scope of works includes hydro-demolition, reinforcing steel repair/preparation, guncrete reinstatement and the application of protective coatings to more than 10,000m² of surface across the walls of the ten concrete silos.
