Bunbury Port – Berth 8 Repairs

PROJECT DETAILS

The Port of Bunbury (PoB) is located on Leschenault Drive, Bunbury, Western Australia. The works described are part of the concrete remedial works package located at Berth 8 at the PoB.

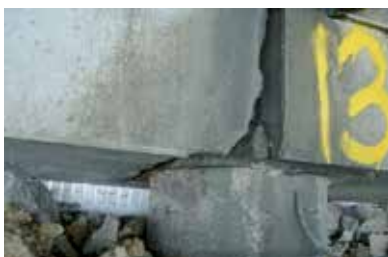
Before

- Rectification of sill beam defects at 42 pile locations (each side of each pile) due to rear concrete sill beam bearing failures over supporting pile caps in addition to varying degrees of concrete splitting and spalling to the sill beams
